**ELLIS ISLAND
STATUE OF LIBERTY NATIONAL MONUMENT**

**HISTORIC STRUCTURES REPORT
UNIT ONE BUILDINGS**

**Volume 2
Part Two**

**Beyer Blinder Belle/
Anderson Notter Finegold**

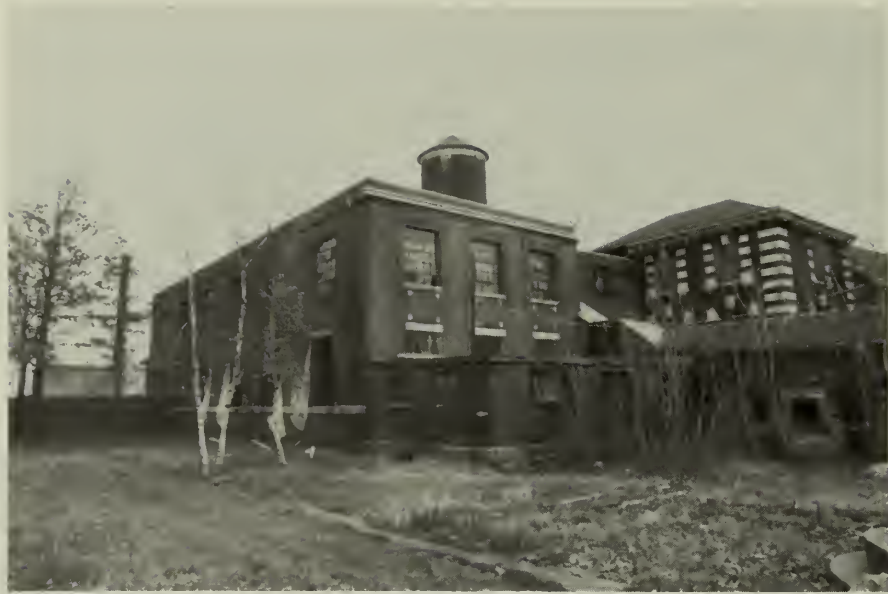
1. West and south elevations, one-story oven room, view northeast.

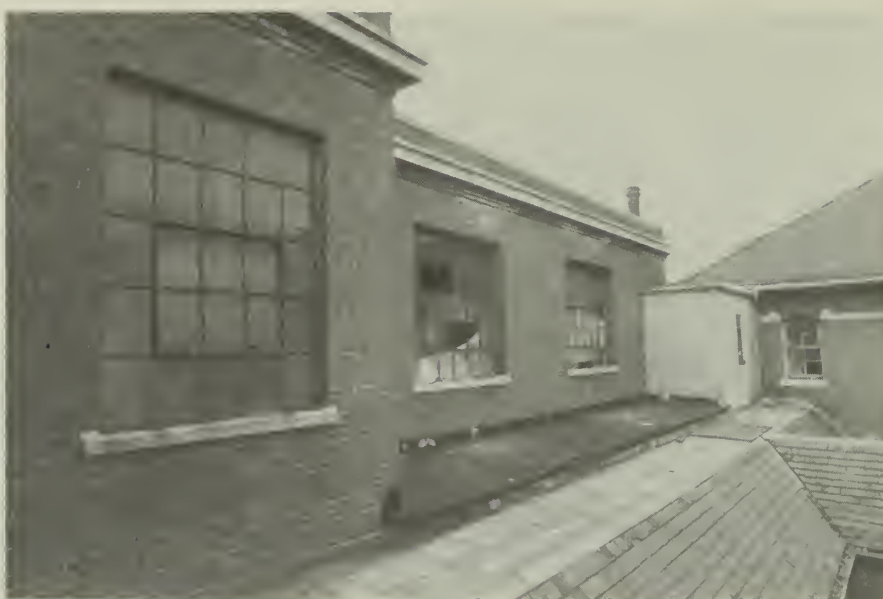
Some efflorescence is present, notably at the corbel table on the south elevation and under the cornice on the east elevation (photo 5). Biological staining is located at the base on the west and north elevations.

5. East elevation, view northwest.

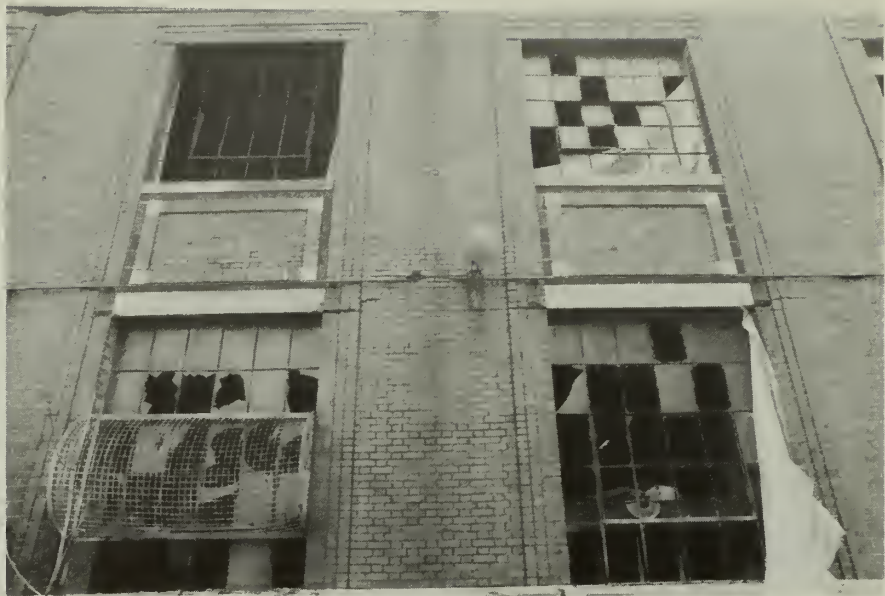
Metal sash windows, as mentioned above, are corroded. More than half have broken or missing glazing, particularly those at the west and south elevations. The latter have been covered with sheets of plastic on the interior for temporary protection (photo 13).

13. Windows, west elevation.

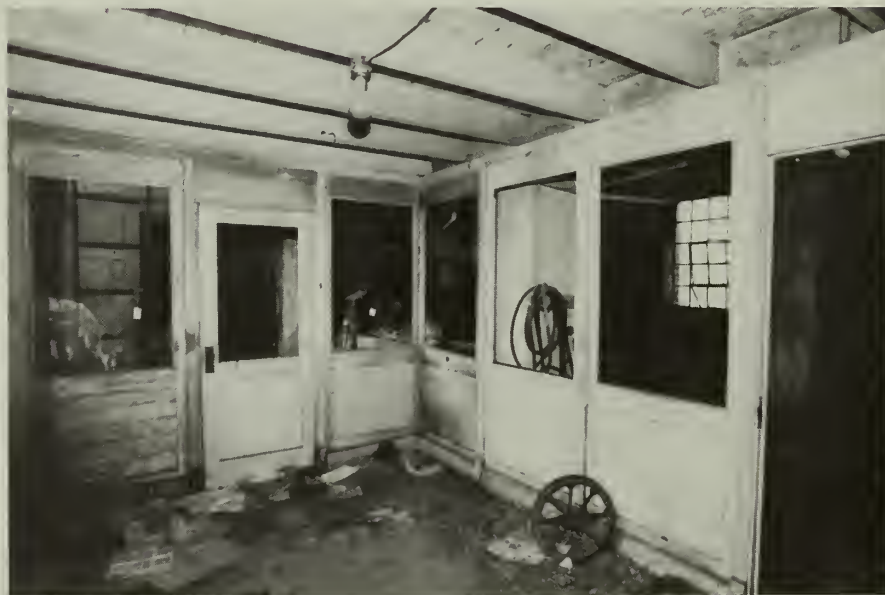
7. Room 203C- wood partitions forming office in room 203.

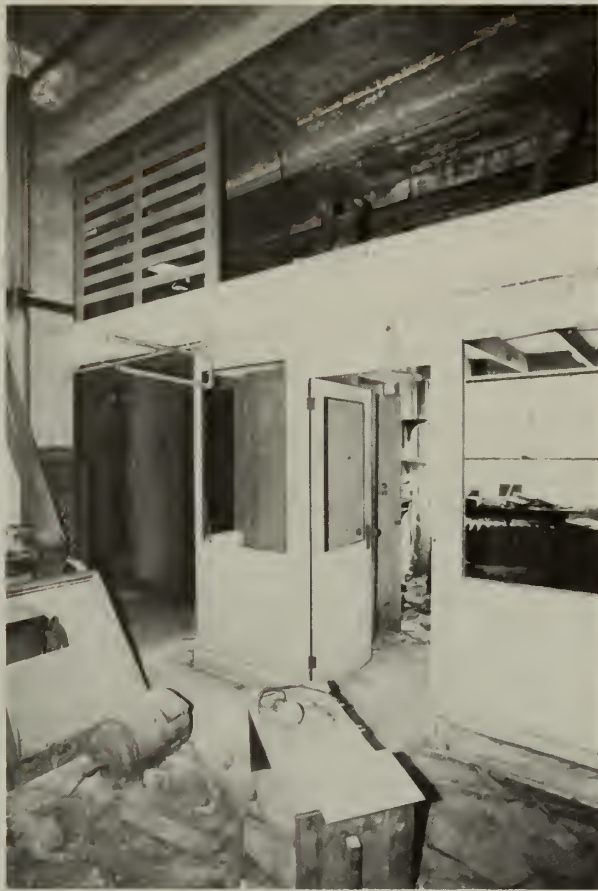
8. Room 203- storage platform forming ceilings of rooms 203B and 203C.

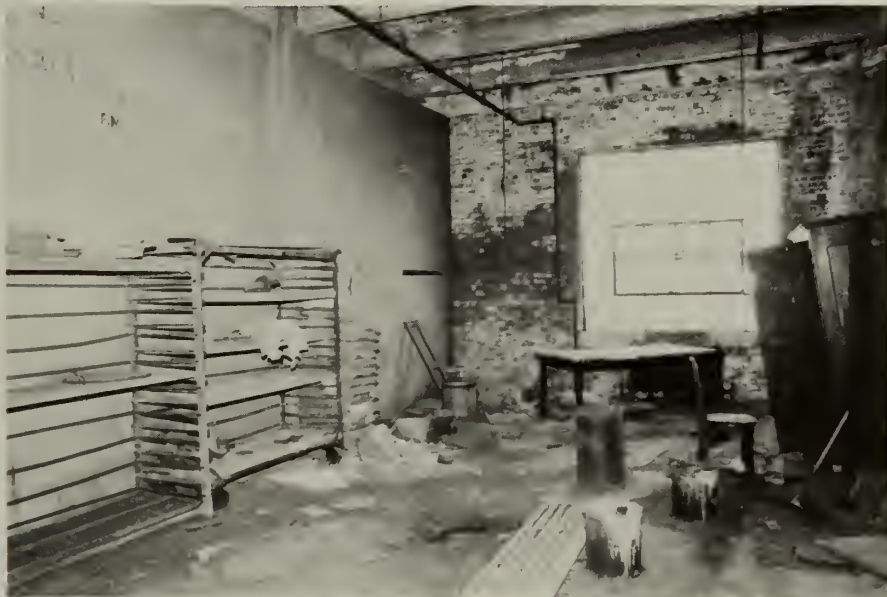
9. Room 202- Peeling paint on brick outside wall, plastered room wall at left, wood flooring.

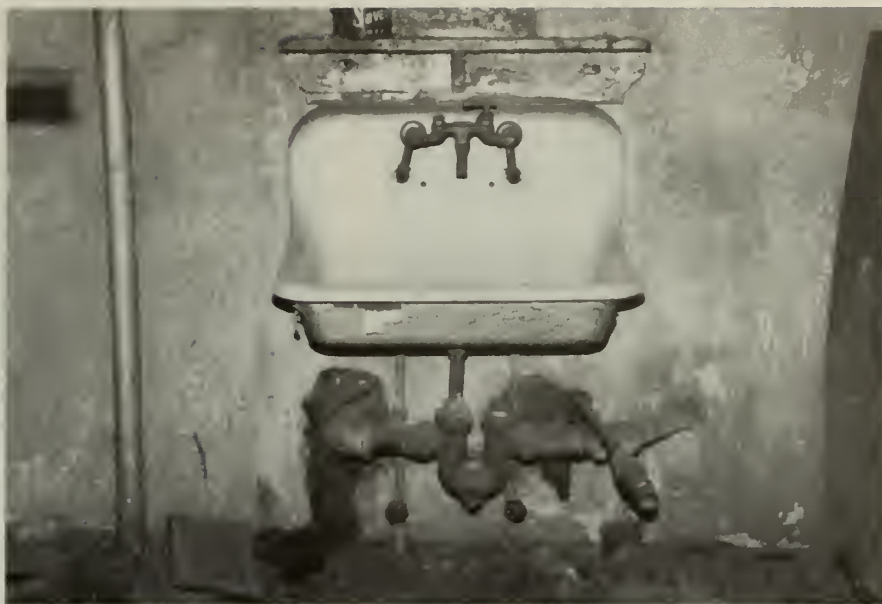
4. Wall-mounted slop sink, c. 1940's, room 203.

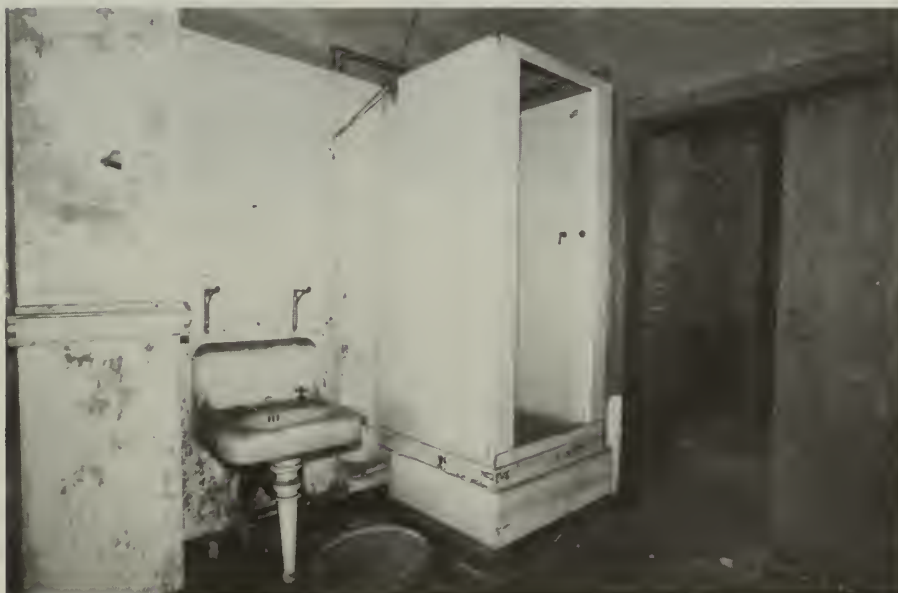
5. Pedestal sink (c. 1920's) and aluminum enclosed shower (c. 1940's), room 202.

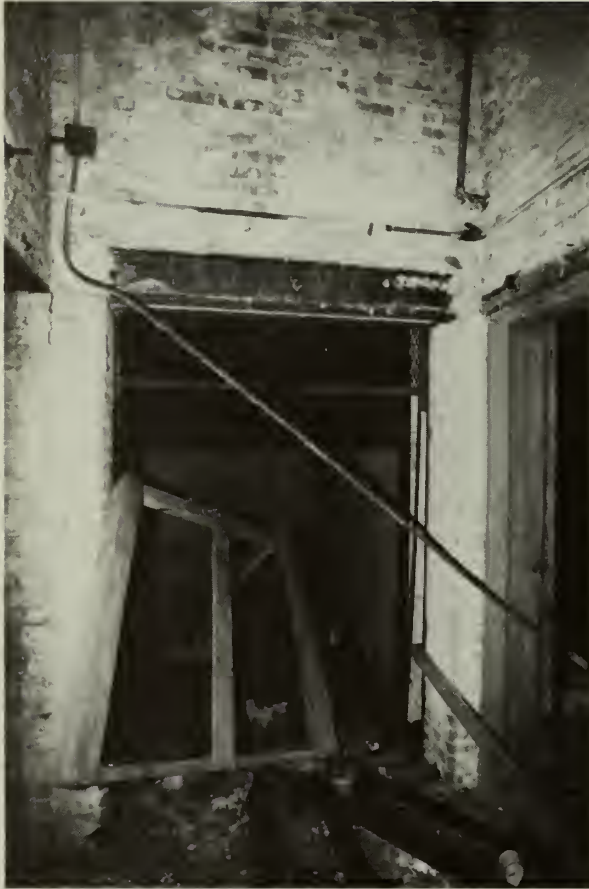
6. Elevator car at first floor hoistway entrance.

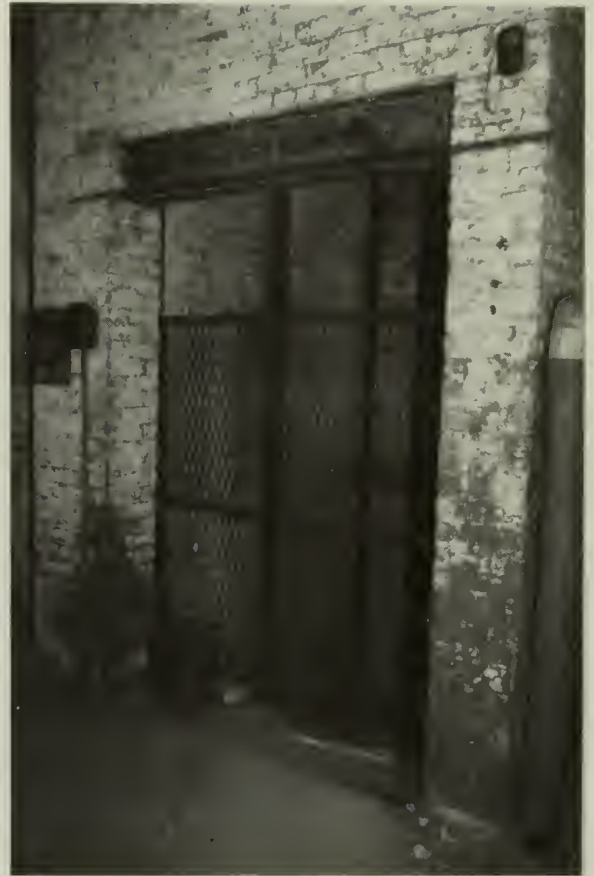
7. Elevator entrance at second floor.

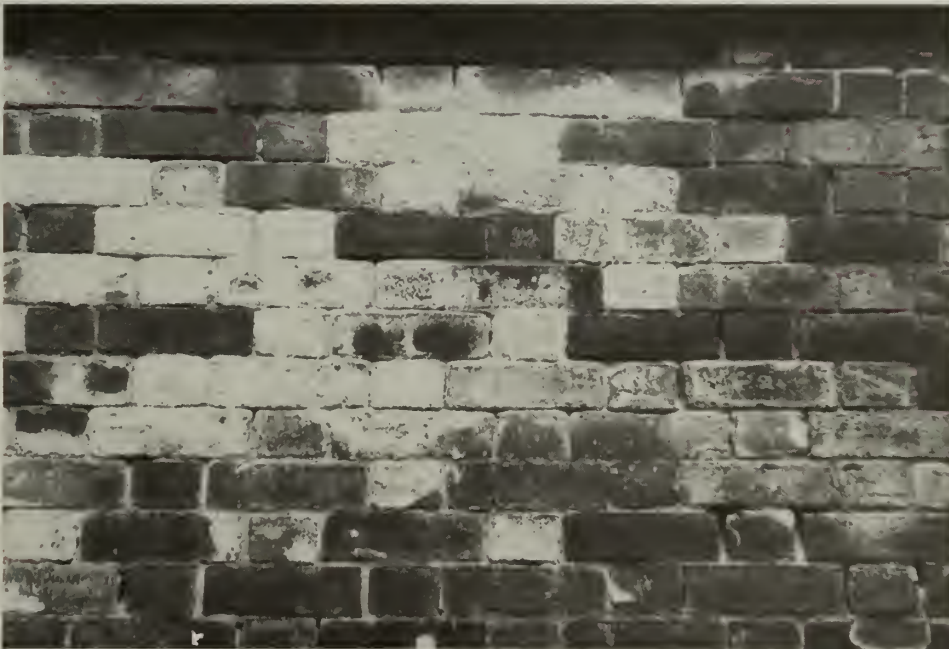
4. Efflorescence, south elevation.

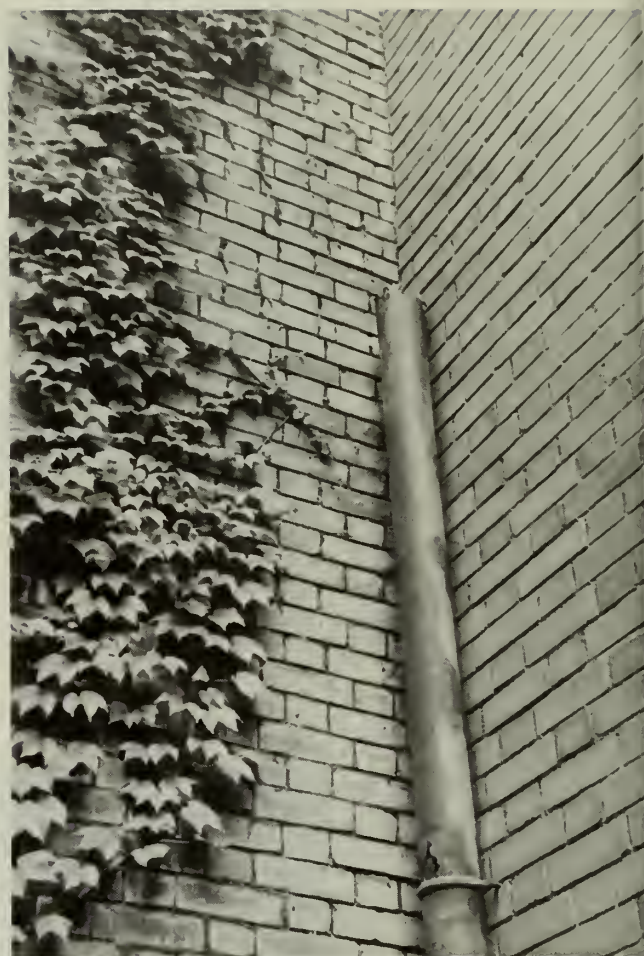
6. Biological staining, north elevation at juncture with corridor 2.

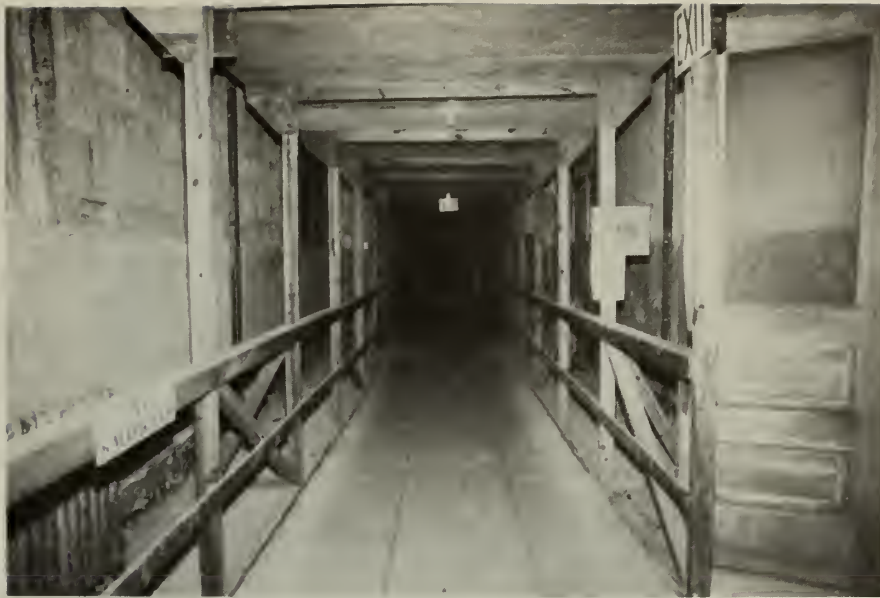
7. First floor of C-1 looking east to main building-
temporary wood railings and overhead protection.

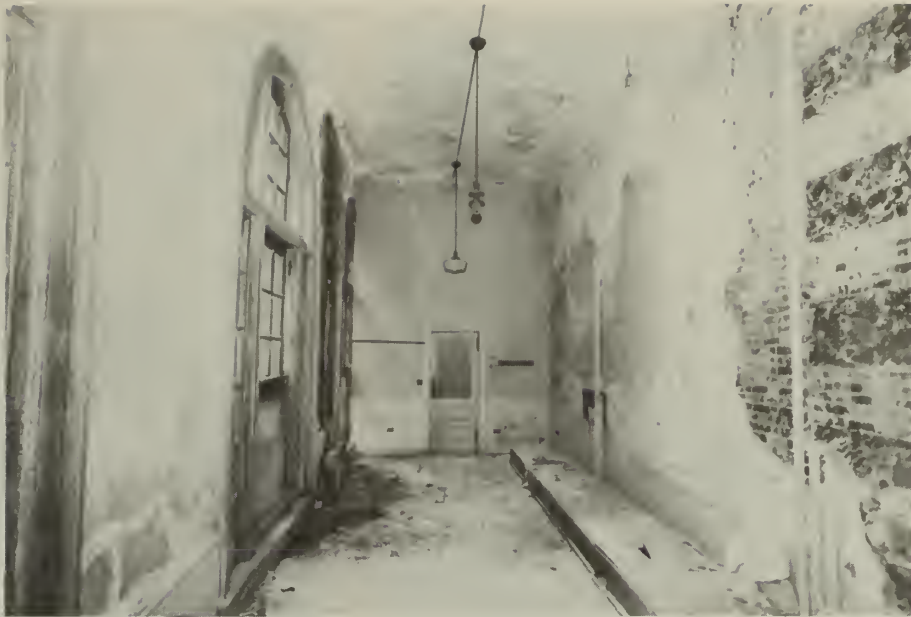
8. Room 105- looking south- raised platform floor over original ramped floor.

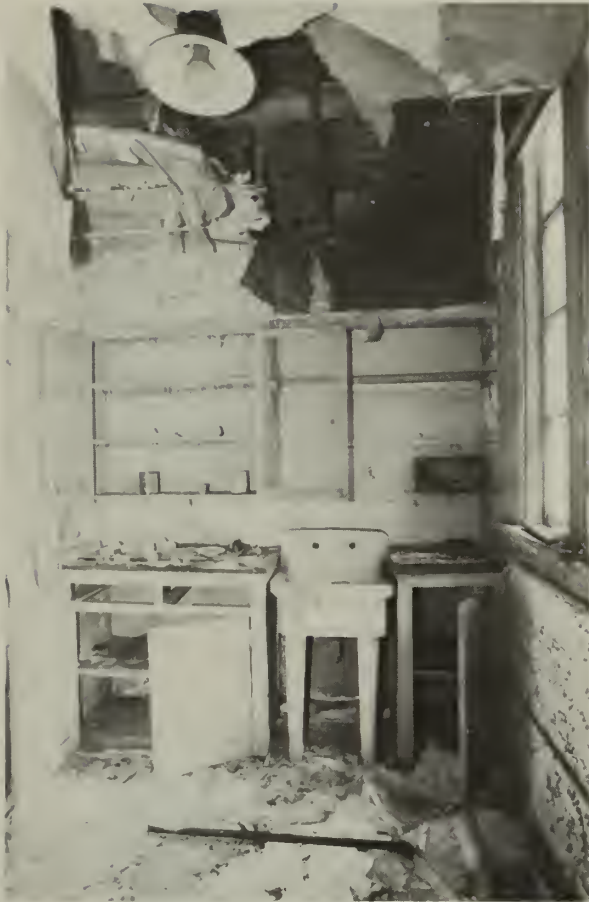
14. Room 103- sink (c. 1930's), lamp with flared cone metal shade.

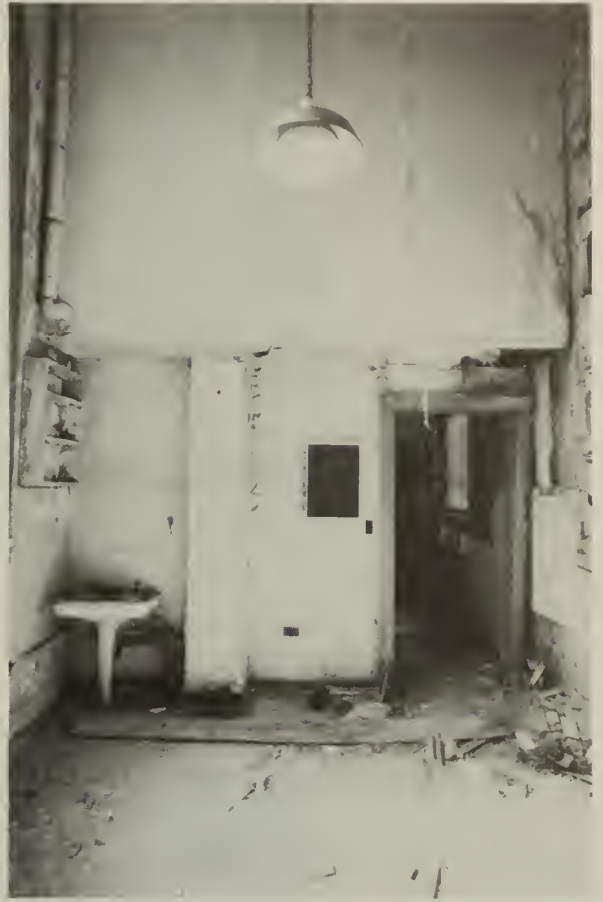
15. Room 102- square pedestal sink (c. 1940's), RLM-type light fixture with glass globe.

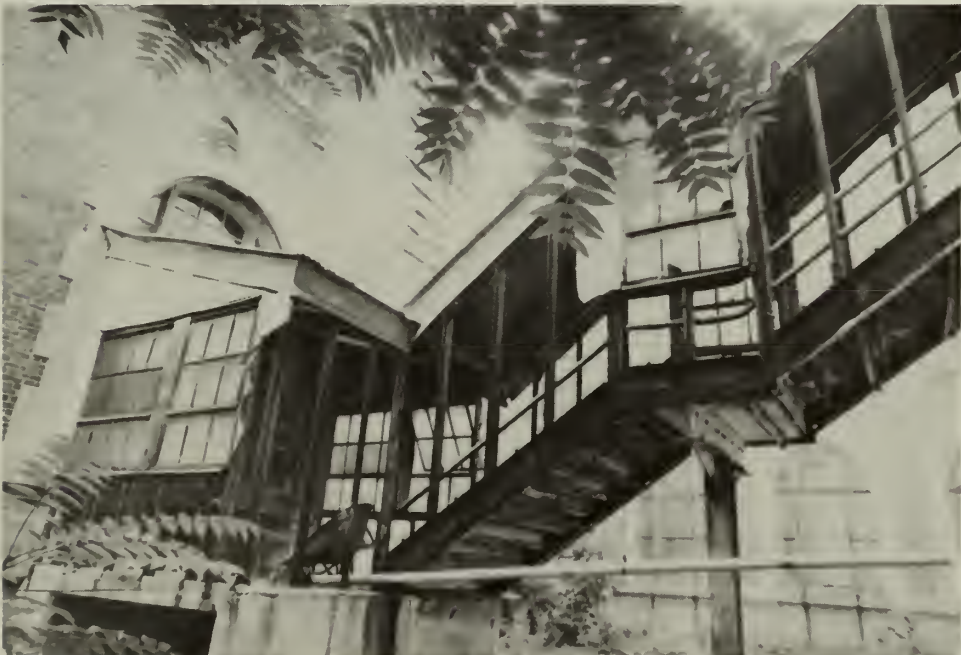
2. View of stair looking west toward platform from first
floor of main buildng. No side sheathing remains.

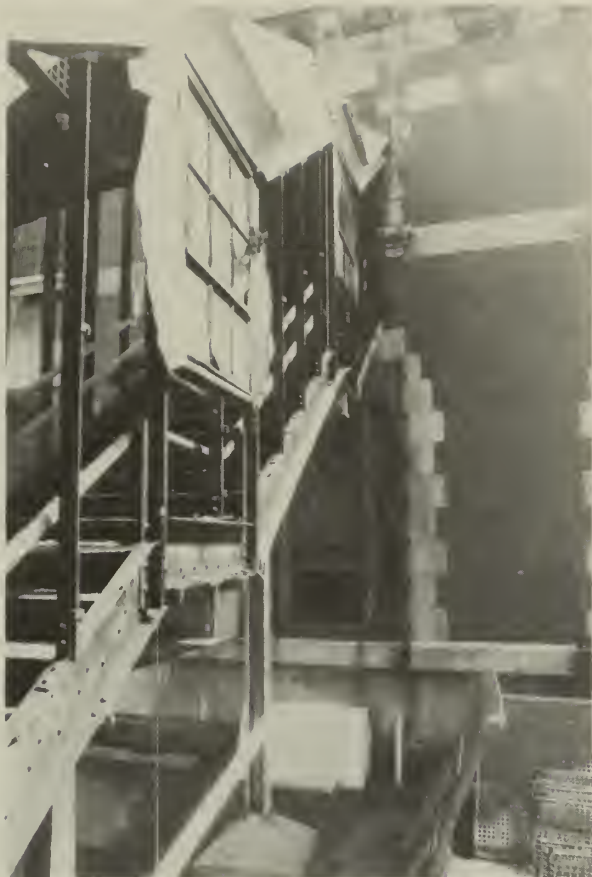
3. East side of stair- pivoted windows at landings.

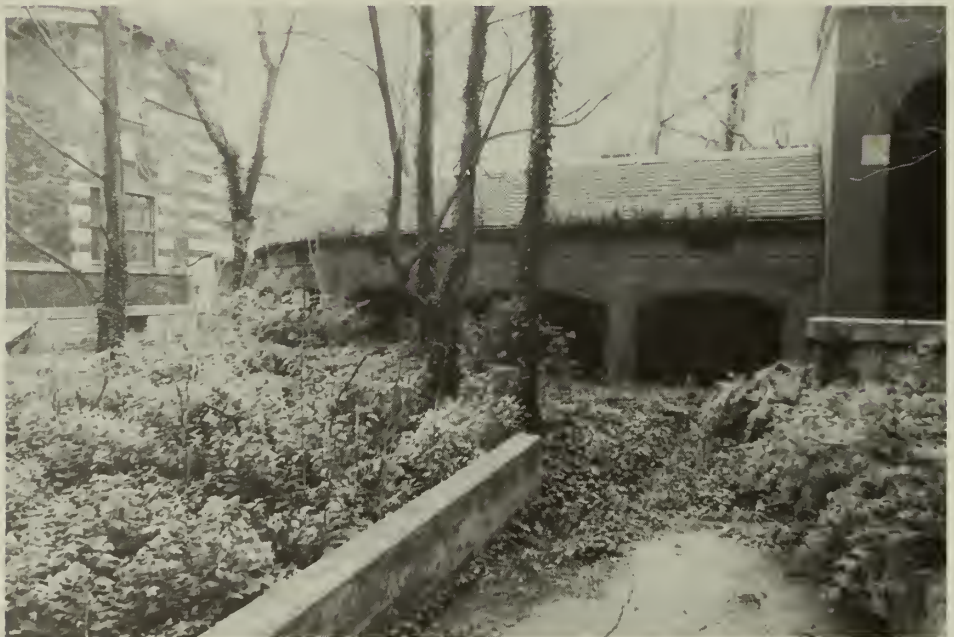
2. East wall of C-4.

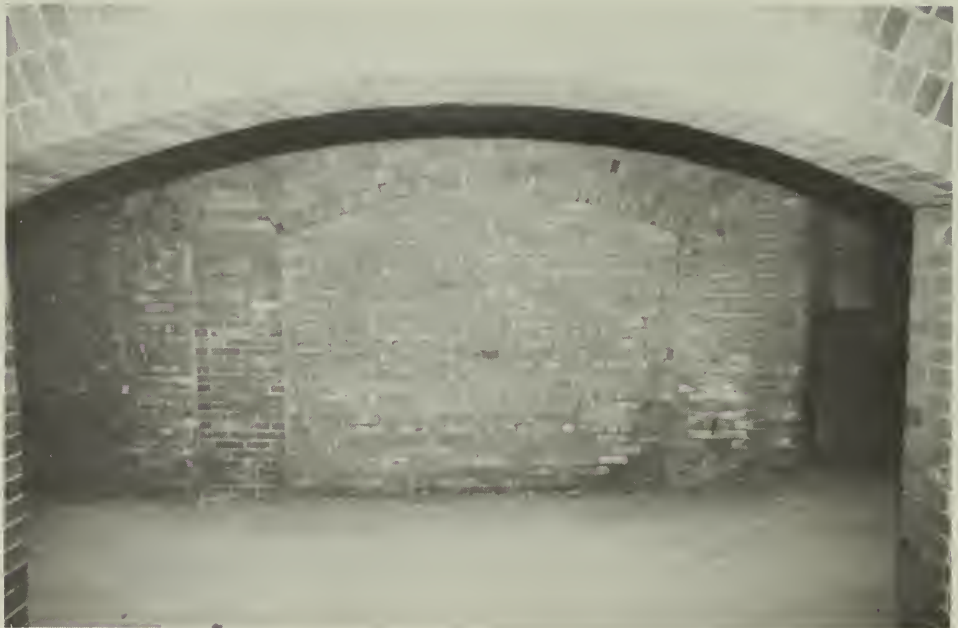
6. C-4- west interior wall with brick filled-in arches.

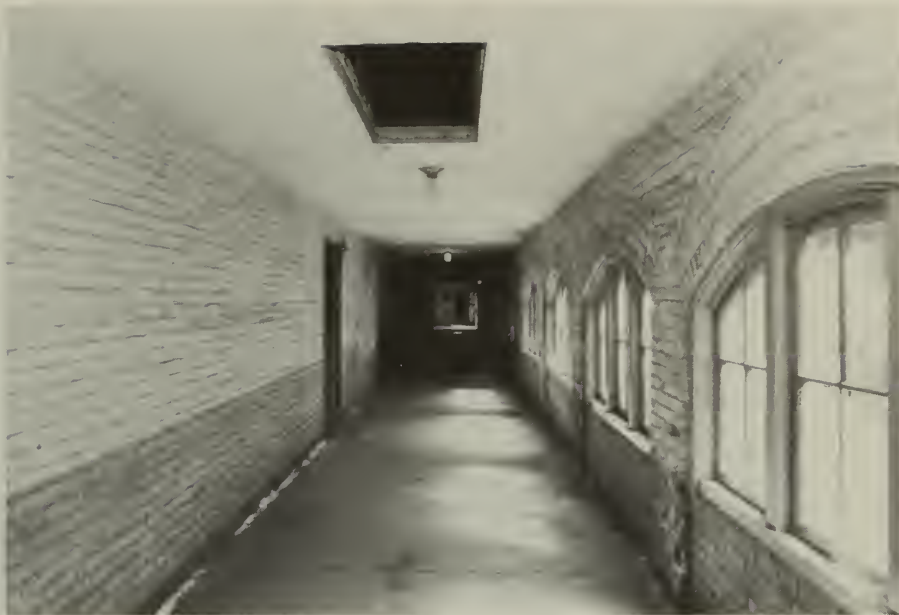
19. C-5- east side of corridor looking north to power-house.

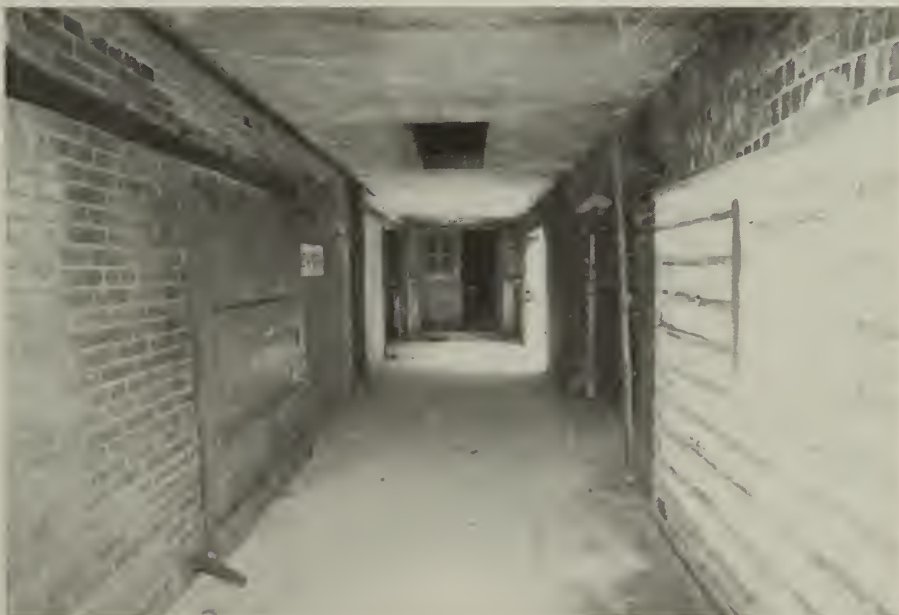
20.C-5- northern section looking toward entry to power-house. Bakery and carpentry at left. Entrance arch to C-4 at right.

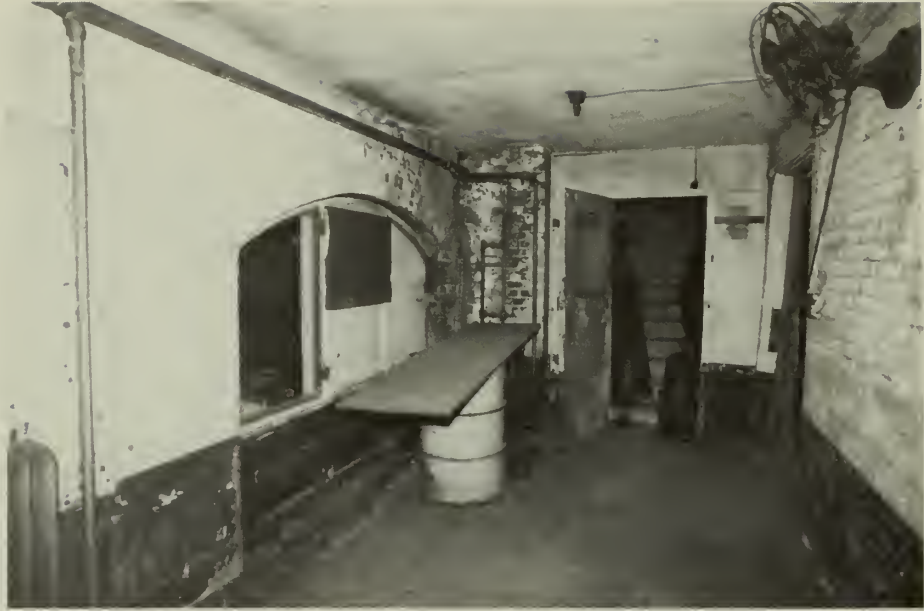
21. Western half of C-5, room 107, looking north to stairway entrance.

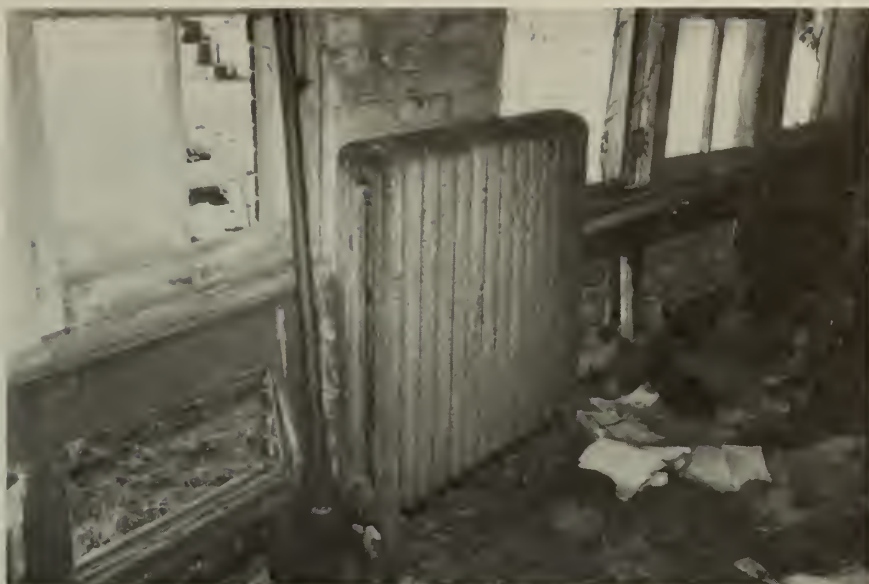
22. Sectional radiator, room 103.

Radiators may be reused after thorough cleaning and testing. None of the existing piping can be retained due to its advanced state of deterioration.¹⁶

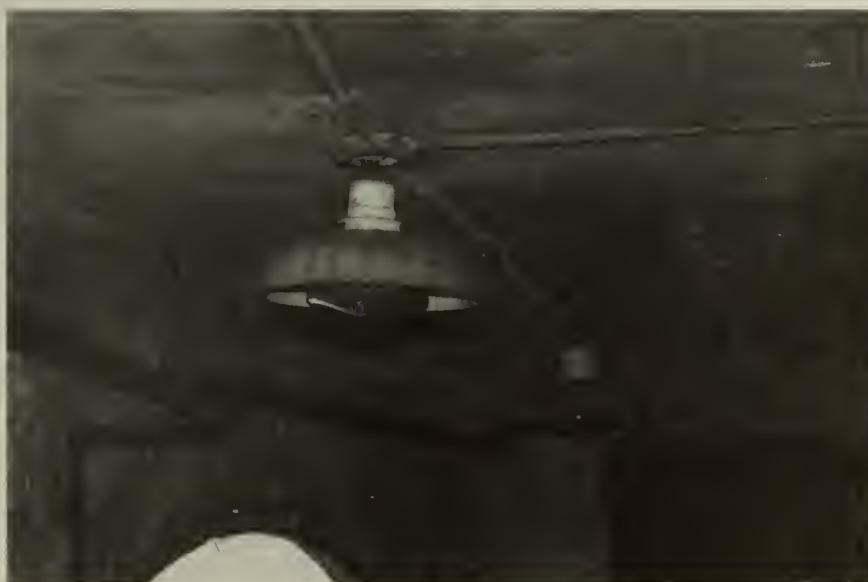
23. RLM-type fixture, typical in western rooms.

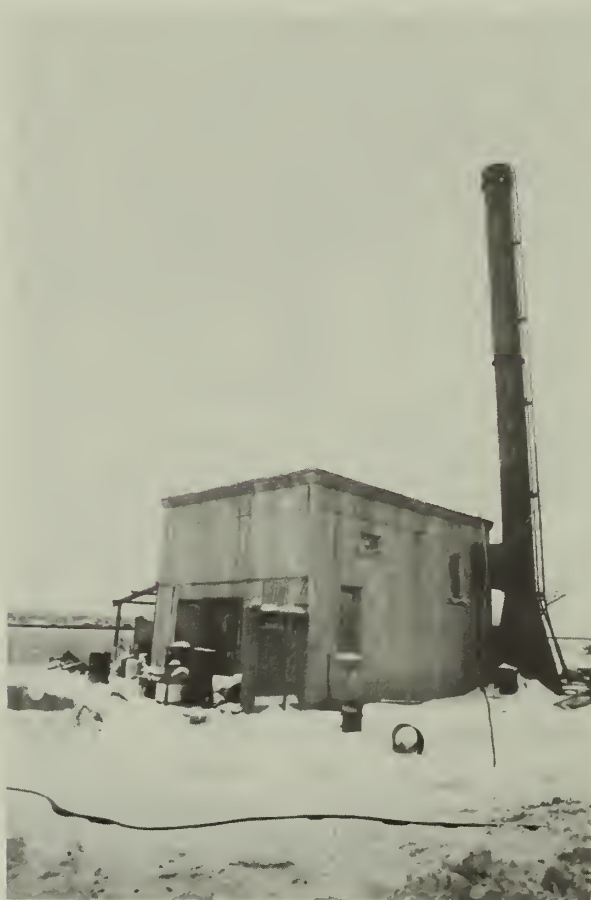
2. South and east facades, smokestack, view northwest.

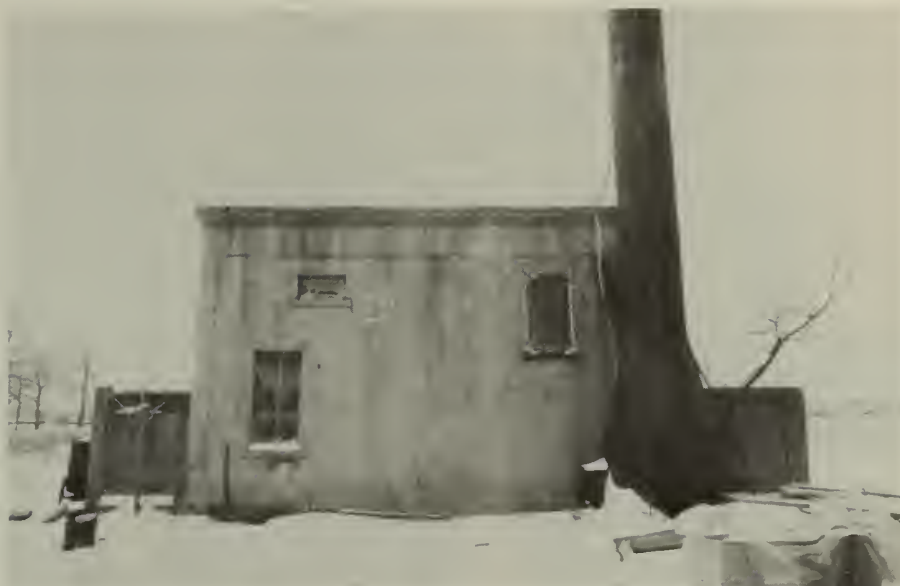
3. East elevation, view west.

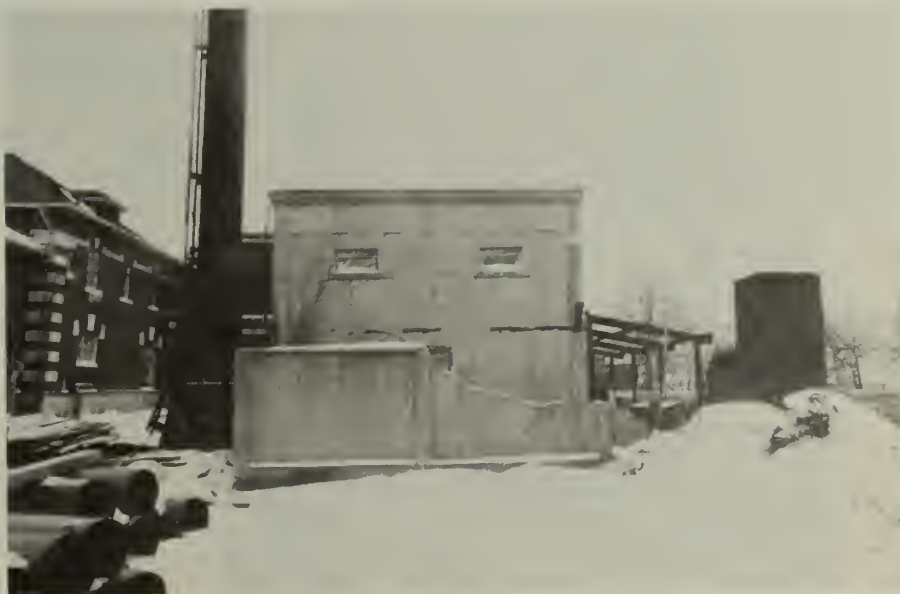
4. North elevation, view south.

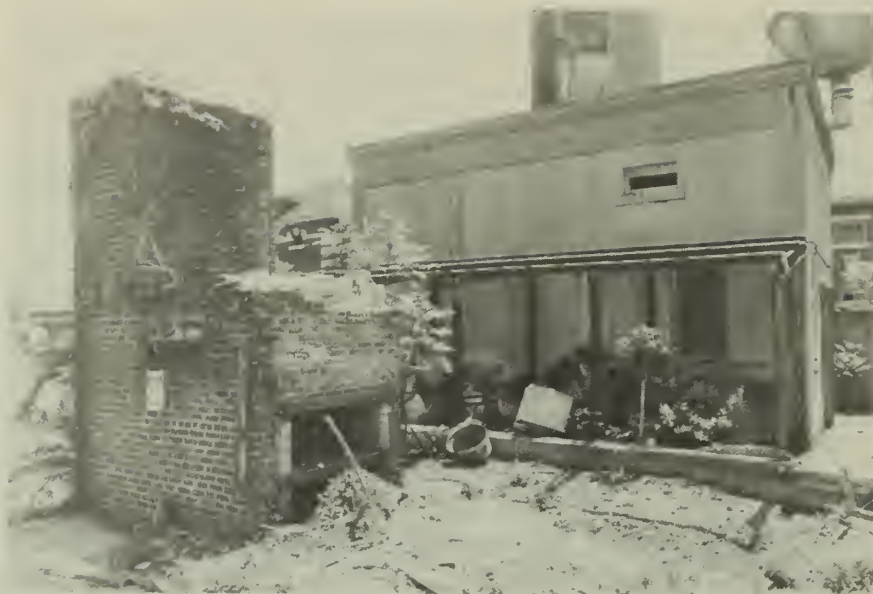
5. West elevation, furnace, view east.

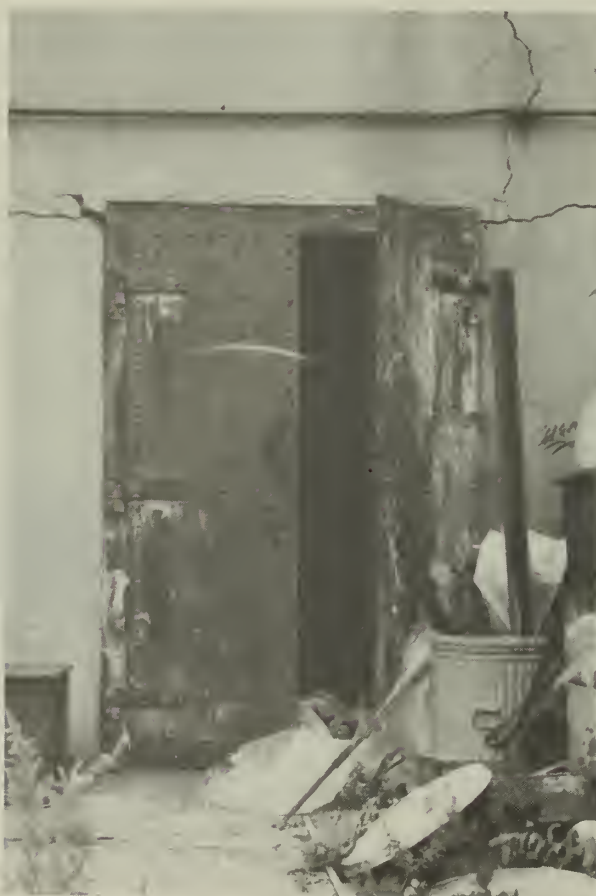
6. Entrance, south elevation, view north.

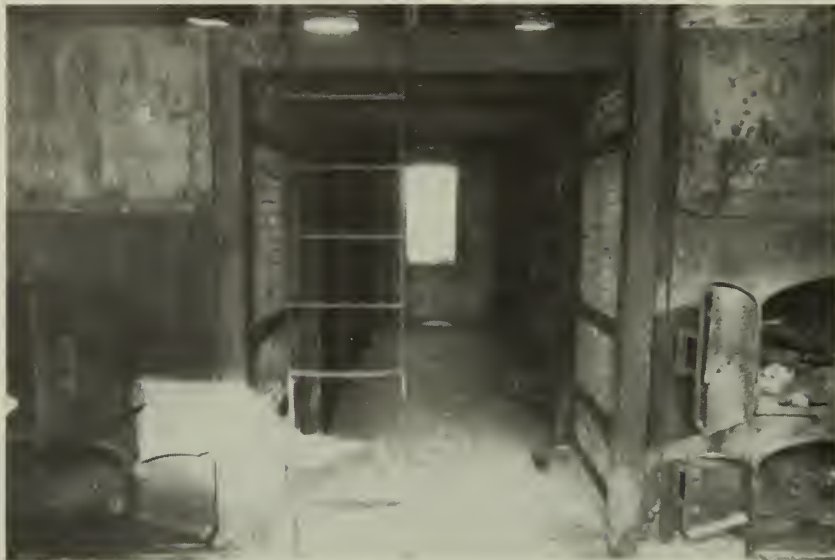
9. View north from entry of incinerator.

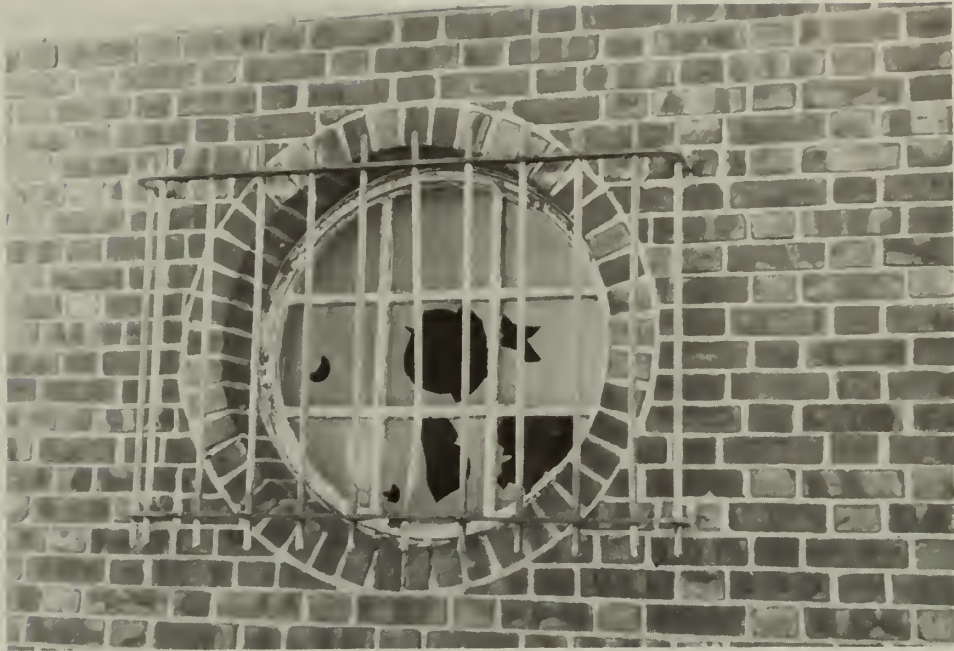
Most window glazing on the east side is missing and the framing deteriorated (photo 6). The brick vestibule appears to be in danger of collapse as it leans away from the building. The roof has fallen in and the southern door is destroyed. The brick facade appears to be in good condition though some spalling has occurred on the west facade, just below the parapet and along the base of the building. A few of the terra-cotta pilaster caps are cracked and some of the pilaster bases are chipped. A few holes in the terra-cotta entablature are present on the west elevation (photo 7). Window guards are corroded.

6. Bull's eye window.

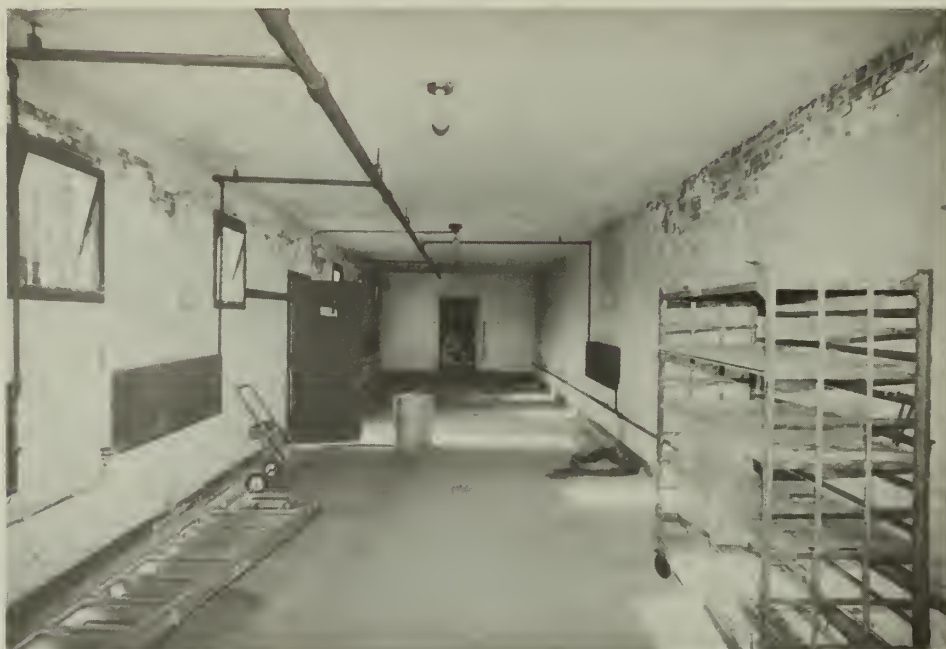
The concrete flooring and ceiling are in good condition. The plaster walls and ceiling of the two end rooms are deteriorating, with areas of exposed terra-cotta and ceiling lath. The center room is in good condition with general wearing away of paint on the brick wall, especially along the top of the wall. A minimum of brick spalling occurs along the base of the west wall.

9. Room 102- view south.

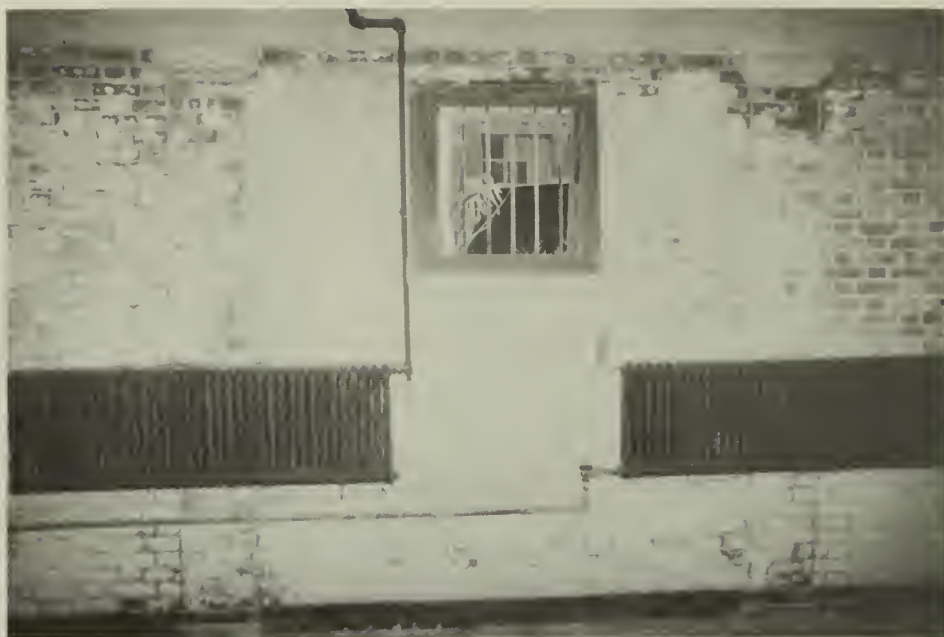
12. Room 102- wall-mounted radiators on east wall.

None of the existing piping can be retained due to the advanced state of deterioration. Radiators may be used after thorough cleaning and testing.

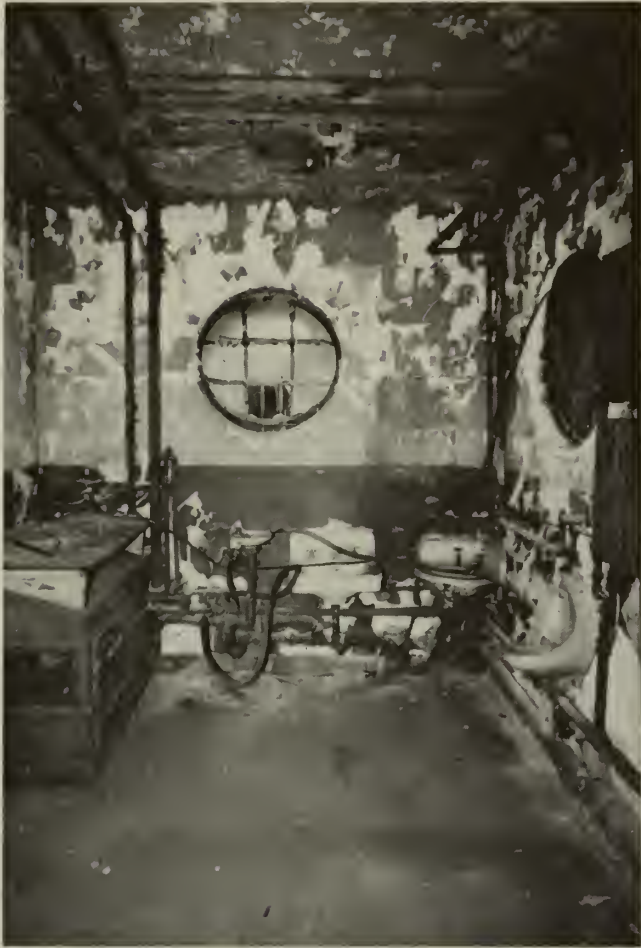
Water for the shelter is provided by an underground water main from the powerhouse that rises up in the toilet room at the south wall of the building. All water supply piping needs replacement. Two sinks, a drinking fountain, a urinal, two toilets, and enclosed aluminum shower units are intact fixtures from the 1940's (photos 13-14).

13. Room 103-view east, two wall-mounted sinks, one wall-mounted urinal, c. 1940's.

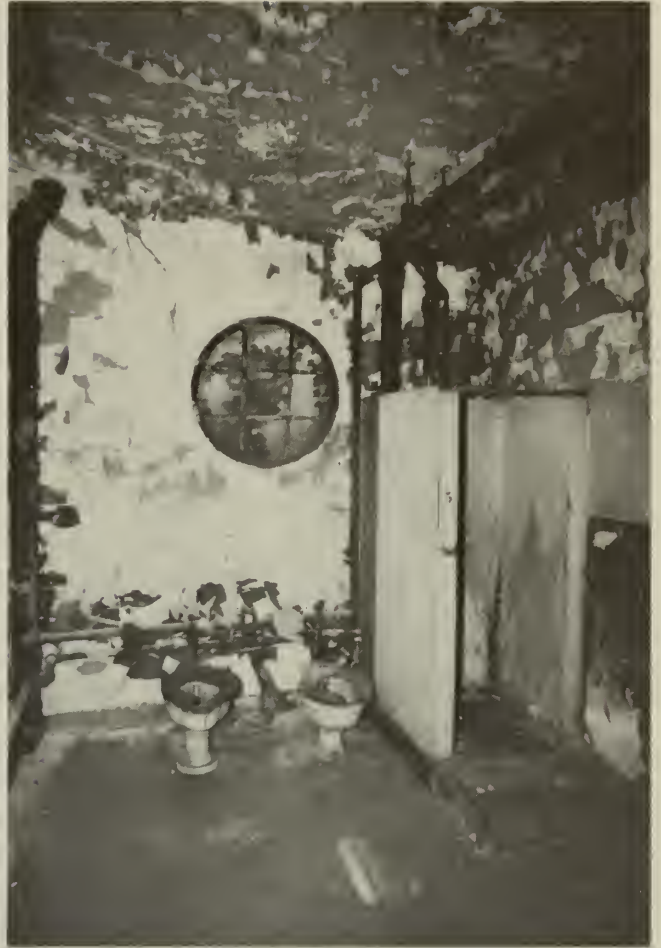
14. Room 103- view west, two toilets, one enclosed aluminum shower, c. 1940's.

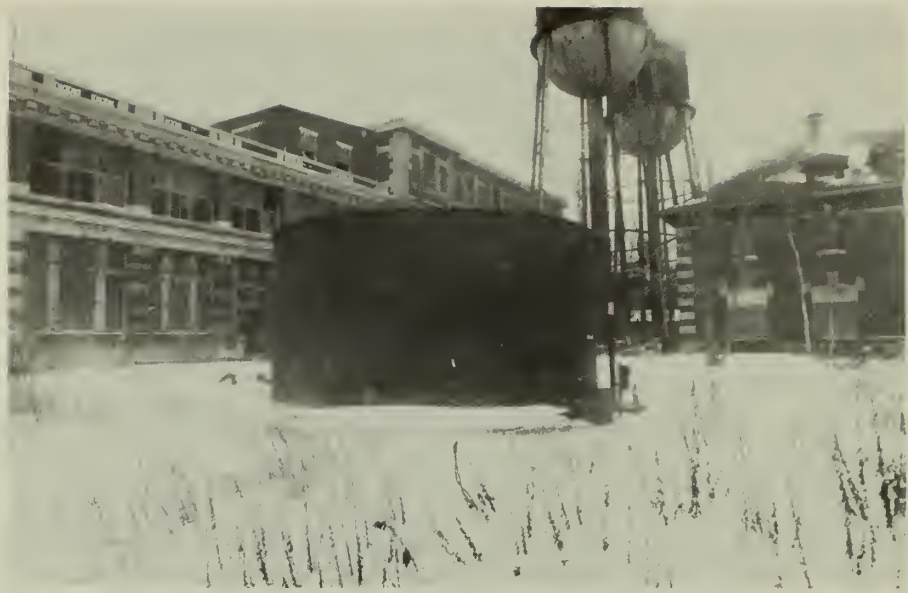
The oil tank foundation concrete is in very good condition and no settlement is apparent. The grout is good but the bottom seal is starting to deteriorate. The tank has one damp spot approximately 15 feet west of the ladder at the bottom to the foundation. Paint on the shell and roof exhibits many skipped areas. No metal pitting occurs though a slight amount of rust has built up near the ladder approximately 6" up from the foundation. The welded tank is full of fuel oil. The pipe connections are good but there is a minor leak in the pump.

1. Oil tank, view southeast.

Repair work for the tank would include cleaning and resealing the foundation, cleaning rust areas at the bottom, and repainting the entire tank. If the tank is taken out of phase, the bottom should be cleaned and vacuum boxed.
